Contract #: 04-0120F4Cty: SF/ALA Rte: 80 PM: 13.2/13.9File #: 69.28**WELDING INSPECTION REPORT****Resident Engineer:**Siegenthaler, Peter**Address:** 333 Burma Road**City:** Oakland, CA 94607**Report No:** WIR-022059**Date Inspected:** 20-Mar-2011**Project Name:** SAS Superstructure**OSM Arrival Time:** 700**Prime Contractor:** American Bridge/Fluor Enterprises, a JV**OSM Departure Time:** 1900**Contractor:** Zhenhua Port Machinery Company, Ltd (ZPMC), Changxing Island **Location:** Shanghai, China**CWI Name:** Lv Li Qing**CWI Present:** Yes No**Inspected CWI report:** Yes No N/A**Rod Oven in Use:** Yes No N/A**Electrode to specification:** Yes No N/A**Weld Procedures Followed:** Yes No N/A**Qualified Welders:** Yes No N/A**Verified Joint Fit-up:** Yes No N/A**Approved Drawings:** Yes No N/A**Approved WPS:** Yes No N/A**Delayed / Cancelled:** Yes No N/A**Bridge No:** 34-0006**Component:** OBG**Summary of Items Observed:**

ULTRASONIC TESTING**OBG SEGMENT 13CE**

WELDING INSPECTION REPORT

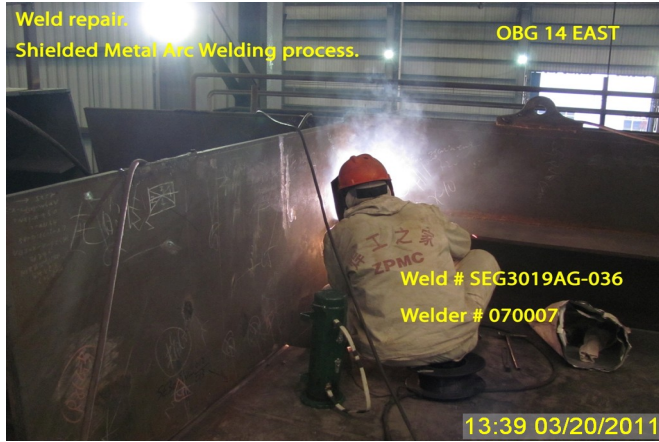
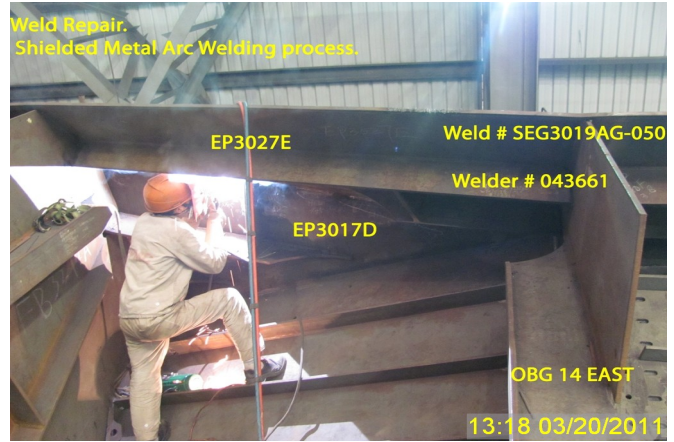
This Quality Assurance (QA) Inspector observed ZPMC qualified welder 068764 performing the Shielded Metal Arc Welding process on weld 035 located at PCMK SEG3019Z. ZPMC QC Mr. Zhu Yuan Yuan was monitoring this welding operation. The welding variables recorded by QC appeared to comply with WPS-B-P-2114-Fcm-1.

This Quality Assurance (QA) Inspector observed ZPMC qualified welder 067571 performing the Shielded Metal Arc Welding process on weld 081 located at PCMK SEG3019Z. ZPMC QC Mr. Zhu Yuan Yuan was monitoring this welding operation. The welding variables recorded by QC appeared to comply with WPS-B-P-2214-Tc-u4b-Fcm-1.

This Quality Assurance (QA) Inspector observed ZPMC qualified welder 070007 performing the Shielded Metal Arc Welding process on weld 036 located at PCMK SEG3019AG. ZPMC QC Mr. Zhu Yuan Yuan was monitoring this welding operation. The welding variables recorded by QC appeared to comply with WPS-345-SMAW-3G (3F)-Fcm-Repair-1. Weld repair report identified as B-WR20469

This Quality Assurance (QA) Inspector observed ZPMC qualified welder 043661 performing the Shielded Metal Arc Welding process on weld 050 located at PCMK SEG3019AG. ZPMC QC Mr. Zhu Yuan Yuan was monitoring this welding operation. The welding variables recorded by QC appeared to comply with WPS-345-SMAW-4G (4F)-Fcm-Repair-1. Weld repair report identified as B-WR20408.

This Quality Assurance (QA) Inspector observed ZPMC qualified welder 066439 performing the Flux Cored Arc Welding process on weld 208 located at PCMK SEG3019M. ZPMC QC Mr. Zhu Yuan Yuan was monitoring this welding operation. The welding variables recorded by QC appeared to comply with WPS-B-T-2233-ESAB.

This Quality Assurance (QA) Inspector observed ZPMC qualified welder 066763 performing the Flux Cored Arc Welding process on weld 001 located at PCMK SEG3019F. ZPMC QC Mr. Zhu Yuan Yuan was monitoring this welding operation. The welding variables recorded by QC appeared to comply with WPS-B-T-2133-ESAB
